1 Introduction

2.1 The current adopted boundary for the Goodleigh Conservation Area was adopted by North Devon District Council in May 2013, amending the original boundary itself adopted in November 1975.

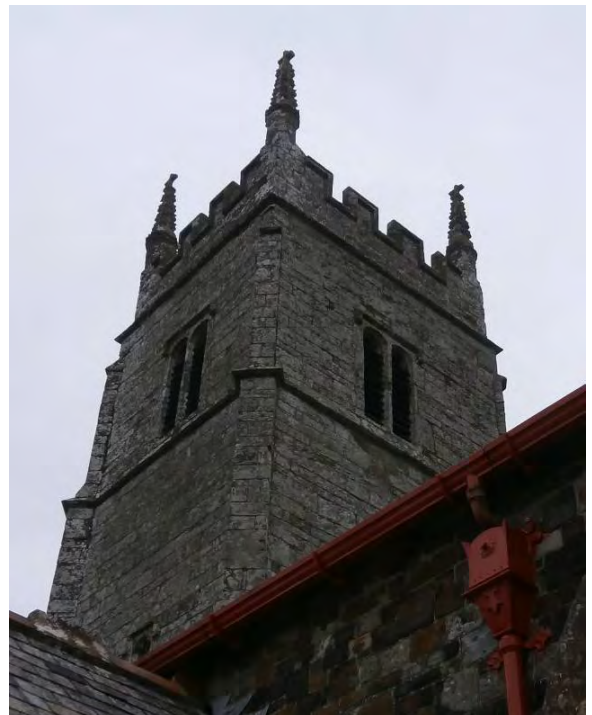
The tower is the oldest standing part of the Parish Church.

4.3 The oldest surviving part of the Parish Church is the West tower which dates to the later medieval period (c. 1350-1550). Much of the rest of the church was almost entirely rebuilt in 1881 by Edward Ashworth who was a prolific restorer of Devon churches in the late 19th Century (Cullompton 1848-50, Tiverton 1853-56, Bideford 1862-65, Axminster 1870, Broadclyst 1882). There was a church in Goodleigh long before the oldest element of the church we see today, with the first recorded parson in 1268 (Thomas de Perers). The Manor lord was given the right to appoint a priest for the parish as early as 1200; although this does not automatically

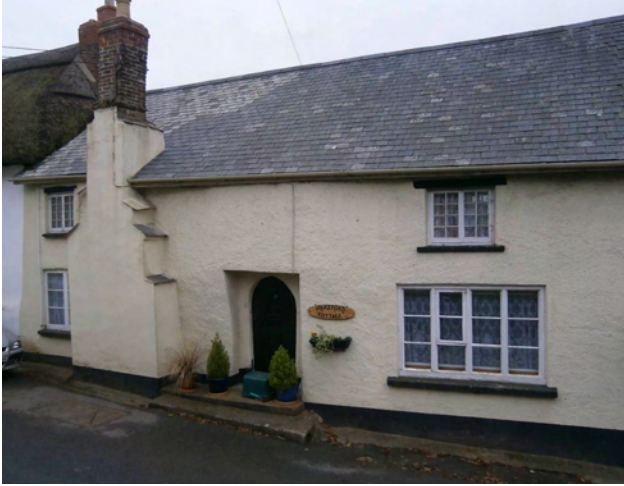
Hakeford Cottage dates to the 16th Century and was used to hold Manor Court sessions.

4.4 Beyond the church the oldest other properties date to the late 16th Century and include The Old Shop, Hakeford Cottage and Willesleigh Cottage with The Cottage being slightly later, probably early 17th Century. Hakeford Cottage was used during the Elizabethan period to host the Manor Court, the lowest court of the country, presided over by the Lord of the Manor. Although by this period the verdict was given by a jury this was selected by the Lord and as members would all have been tenants, reliant upon the goodwill of the Manor Lord there was always the potential for corruption.

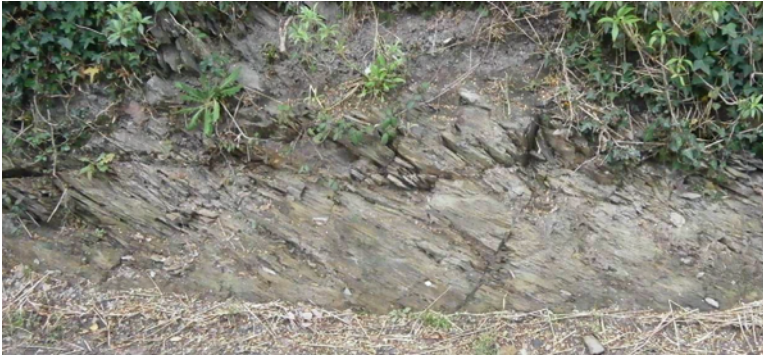
In places the exposed local bedrock can be seen above the ground level.

5.5 In places the exposed bedrock can be seen, a slate/shale with the beds at near 45 degree angles where they have been subject to heave in the past. This is particularly apparent at the base of the tall retaining wall to the South of The Old Forge.

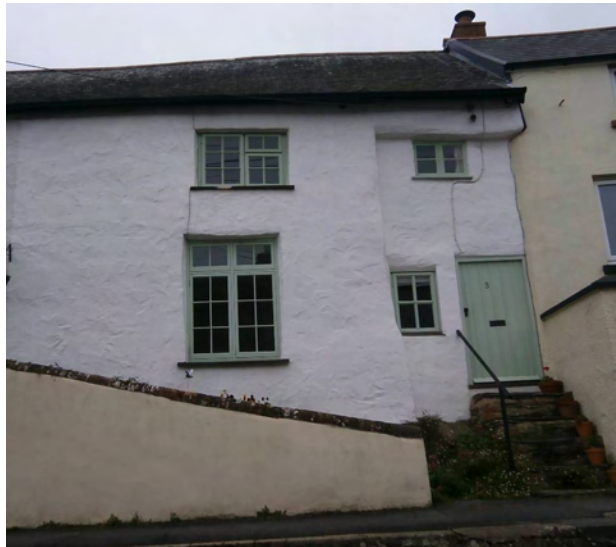
3 Bank Cottages has a variety of casement windows of varying age and character.

7.9 3 Bank Cottages is a good example showing different window styles. The ground floor example is flush fitting and has a good traditional appearance, free from bulky projections and overlaps; however it does incorporate top hung opening lights which are not traditional. The window above has storm-proofing which makes the frames appear more bulky as well as top hung and side hung opening elements, while the small window above the front door is a genuinely traditional flush fitting casement window with one side hung opening light and one fixed light.

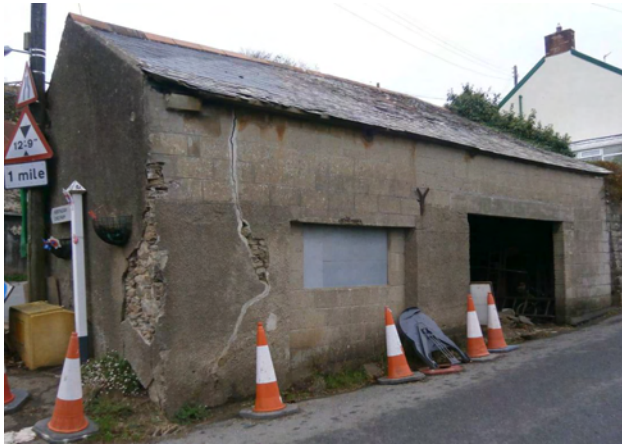
The former Blacksmith's shop at the East end of the conservation area.

7.12 At the Eastern end of the village the main road forms a junction with the road to Chelfham. Around the junction are clustered a number of lower status storage buildings, currently in use as stores, workshops and garages but previously these buildings have housed local industry including the village blacksmith's shop (shown on 1st series Ordnance Survey Maps). The buildings themselves are made up of a mixture of materials, including stone, brick, concrete blockwork and even corrugated iron, all with timber or blockwork infill of former openings and corrugated metal

7.13 Although these buildings can hardly be considered to be stunning examples of high quality architecture they do serve as a reminder of the small scale industrial activity which, in the relatively recent past, would have been present in almost every settlement across the country. As such these buildings are an integral part of the character of the village and they preserve an element of the history of the community.

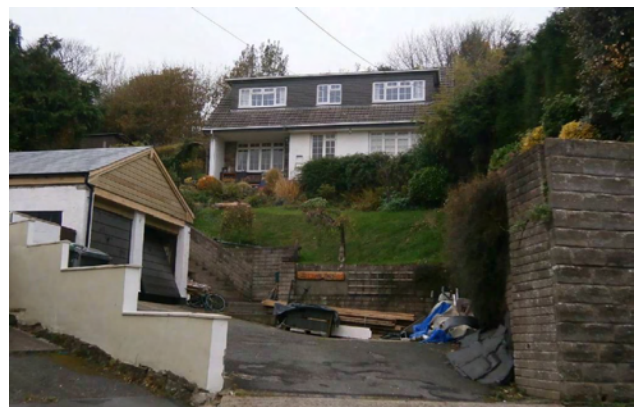
New buildings like Sunny Heights break the conventional building line and introduce modern materials out of character with the area.

7.16 Sunny Haven and Sunny Heights are two modern detached properties along the North side of the main

Goodleigh Road. The buildings are set far back from the roadside, unlike the majority of properties in the village. While Sunny Haven is largely hidden from view by planting, except from the East, Sunny Heights is prominent, fronted by its tarmac driveway, and concrete block retaining walls. The building is rendered with an interlocking concrete tile roof and a large full width tile hung dormer which is out of keeping with the local area where dormers are rare and those which are present are small and tile hanging is not found at all. The recessed porch area on the ground floor is stone clad to provide some hint of natural material, although exposed stone is only really seen on retaining walls and boundary walls in the area. Sunny Haven is similar, rendered, with tile hung gables, exposed red brick panels on some walls and a red brick externalised chimney stack.

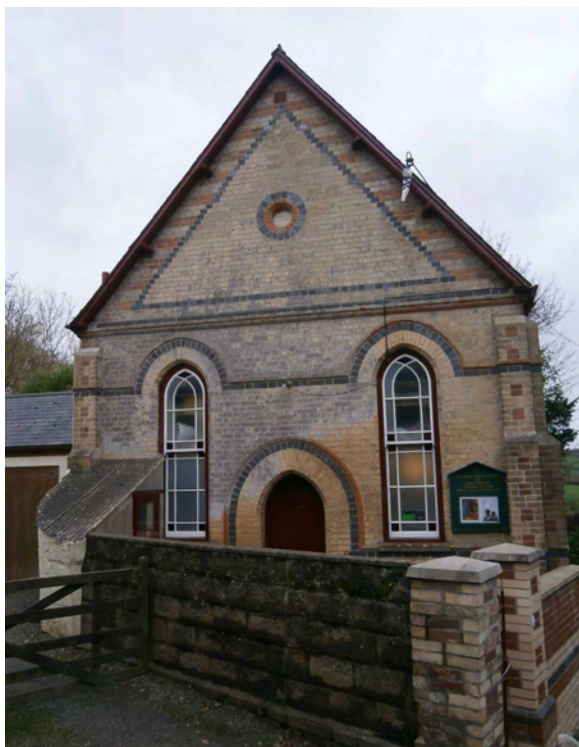
The United Church is an excellent example of Victorian structural polychromy.

7.17 The Bible Christian Chapel (now United Church) was built in 1880 and is a fine example of a high Victorian Gothic Revival style chapel, decorated by structural polychromy, a way of using materials of differing colours (in this case blue/black, cream and red bricks) to produce decorative patterns and to highlight features within a building. Even the enclosing boundary wall gets this treatment, part of the wall having been recently rebuilt taking care to replicate the colourful decorative pattern.
