1 Introduction

1.1 This Conservation Area Management Plan for Woolacombe follows on from the Conservation Area Character Appraisal for the village that was adopted in March 2009.

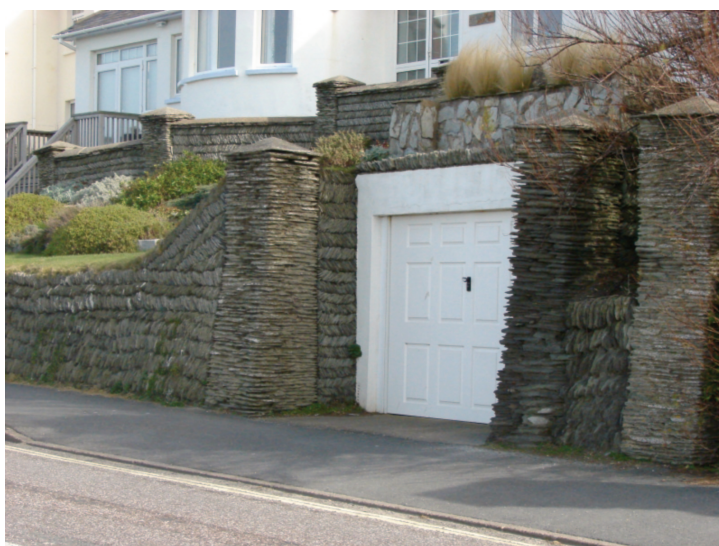
Elaborate walls of herringbone slate, with matching gate piers are amongst the most striking examples of morte slate walls within the conservation area.

5.1 Woolacombe features many boundary walls, and Morte Slate can be seen in boundary walls, especially in the northern parts of The Esplanade. The White House has a particularly splendid group of Morte Slate walls and gate piers with slates arranged in a herringbone pattern.

5.8 Throughout the northern parts of the conservation area and along the Esplanade the local Morte Slate has been put to a variety of uses, and the most widespread and visible example is the use of the material in boundary walls. The local slate is laid in a variety of ways, including a decorative herringbone pattern, which add variety and visual interest to the conservation area.

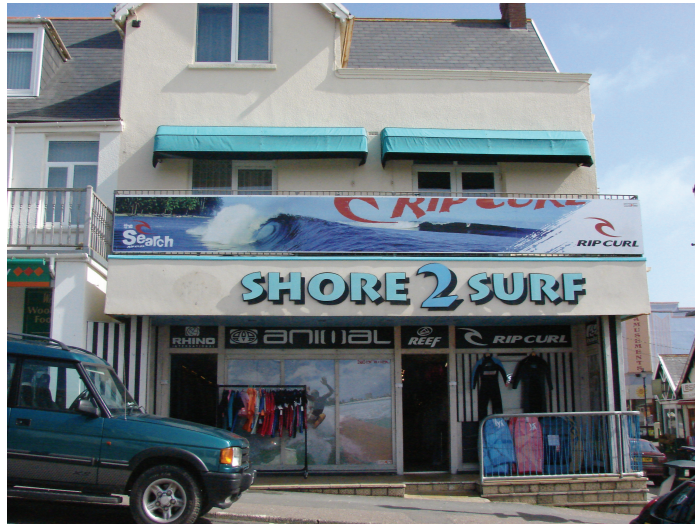
Windows obscured by printed images and banners obscure upper floor balcony railings that form an architectural feature of the row of shops, as an example of poorly conceived shop signage.

- Retention of features – An important element of retaining traditional features is that they should remain visible, which is a particular issue along West Road where balcony railings to the upper floors are sometimes obscured by secondary signage that is often unnecessary.

- Signage – There was a time when the emphasis was on quality, legibility and illustration of function. Today the approach to shop signage seems to be to achieve the largest and brightest advertisement. Clumsy box fascias and totally obscured windows draw attention in the wrong way and detract from neighbouring businesses. Illumination should only be considered for businesses that trade at all hours and then should be limited to that needed for identification.

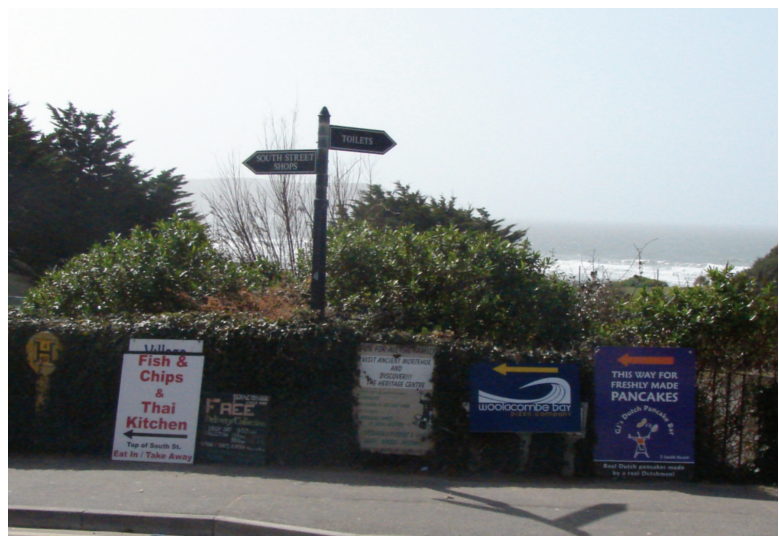
Excessive, poorly designed and inappropriately located signage erodes the character of the conservation area.

7.4 The single biggest issue affecting the appearance and character of Woolacombe conservation area is the proliferation of signage. This is especially a problem around South Street where the majority of the village's shops are located. Much of the signage has been erected without advertisement consent and is displayed on a seasonal basis. The issue now is that there is such a large number of signs that it is difficult to determine which have consent and which do not, and the temporary nature of the signs makes it difficult to enforce against them.
