1 Introduction

3 Why is the Rumsam Conservation Area Special?

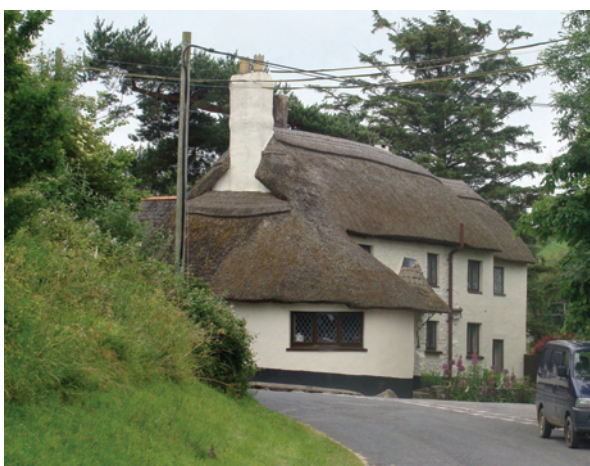
The Old Thatched Cottage is the only thatched building within the proposed conservation area.

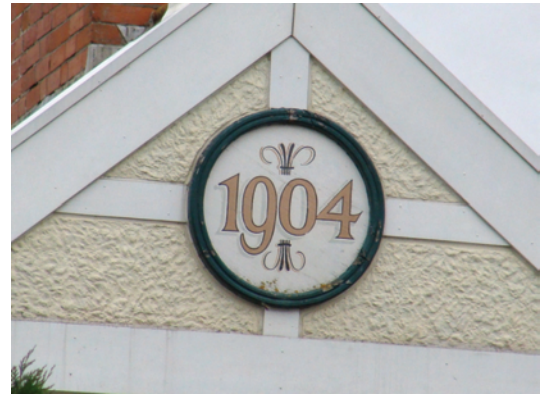
The Old Vicarage carries its date of construction on a gable cartouche.

4.11 The development of the triangular plot of land between Bishops Tawton Road, Rumsam Road and Fortescue Road also began during the Edwardian period with the 'Old Vicarage' built in 1904 and the grandiose terraced row of 1-4 Fortescue Road shown as half built on the 1906 second edition Ordnance Survey map.

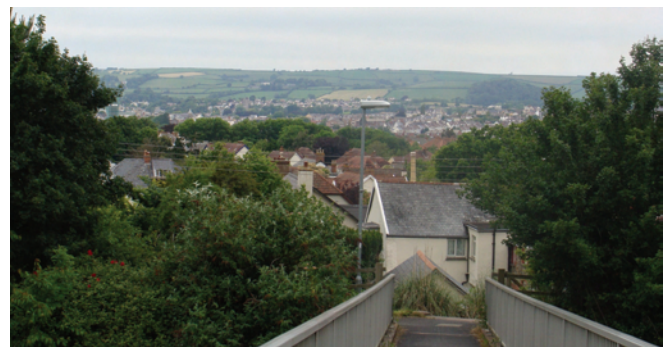
From the A39 footbridge at the southern end of Rumsam Road views out across the Taw Valley are possible.

6.4 From the southern end of Rumsam where steps lead up to the footbridge over the North Devon Link Road (A39) it is possible to look back over Rumsam and Newport to Barnstaple and beyond to the natural green landscape of the Taw Valley's slopes. Landmarks such as the Spire of St. Peter's Church and the tower of Holy Trinity Church stand out in this view which encompasses much of the urban development of Barnstaple and its surroundings.

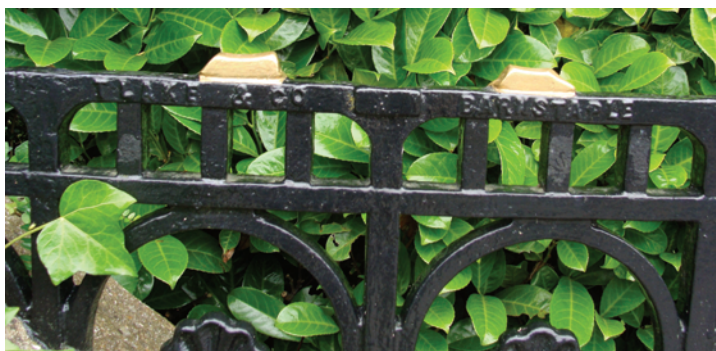
This section of cast iron decorative railing has lost its upper sections (stumps painted gold) but retains the name of the foundry where they were produced.

7.3 A varied pallet of building materials can be seen throughout the conservation area. Red brick and Marland brick appear together, creating polychrome decoration on buildings, and separately. Render is common on Georgian Villas and the earlier modest cottages, while some use of exposed stone can also be seen, primarily in boundary walls. Other materials such as metalwork also survive, including a length of cast iron railings bearing the name of their local manufacturer (T Lake & Co. Barnstaple) at Chilbury.

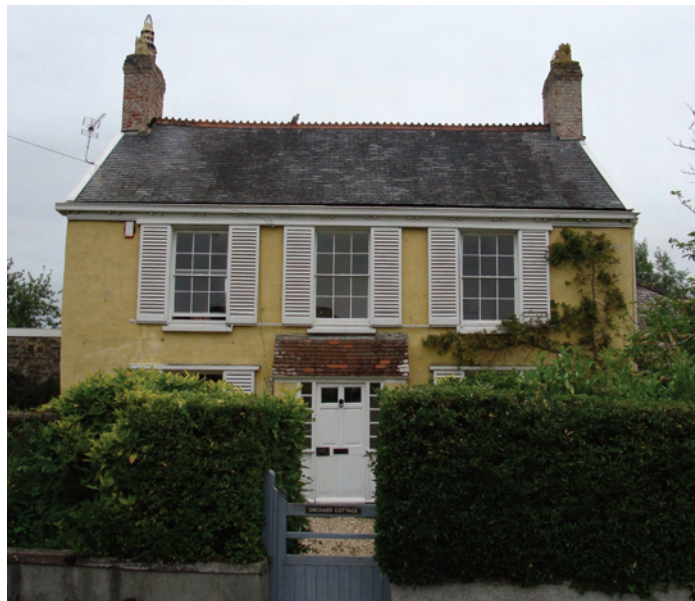
Several Georgian villas retain features such as external shutters which have usually been lost over the years.

7.8 The Georgian buildings along Rumsam Road can be readily identified by the symmetrical elevations and white rendered walls, with examples such as 'The Myrtles', Rumsam Villa and The Laurels being particularly fine. Many also have decorative features borrowed from ancient Greece and Rome, such as doorways flanked by columns supporting pedimented porches, and dentil moulding at eaves level. Other features such as timber window shutters are also retained, such as at Orchard Cottage. Shutters are just one traditional feature which has been incorporated into the design of more recent housing adjoining the conservation area, in this case at Rumsam Gardens, where buildings also feature porches with classical columns.

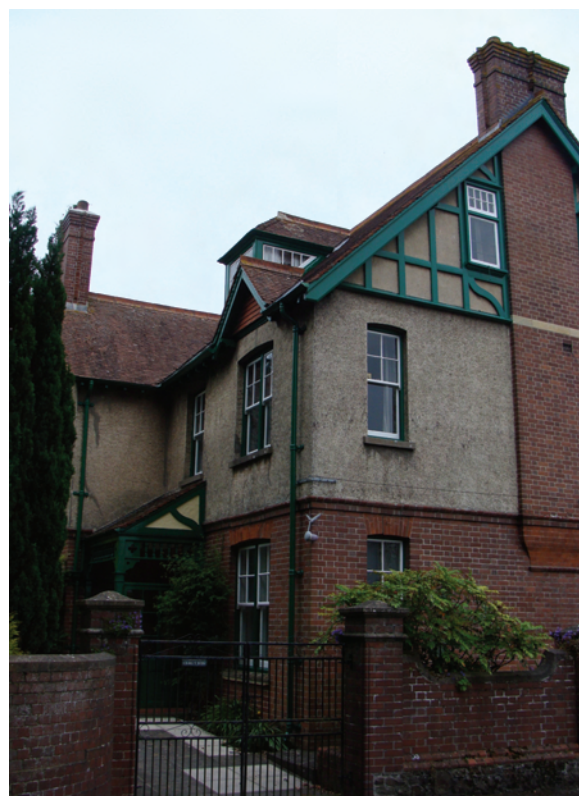
The Arts-and-Crafts style incorporated design features such as timber framing and the extensive use of gables and dormers, tile hanging and open porches can also be seen here.

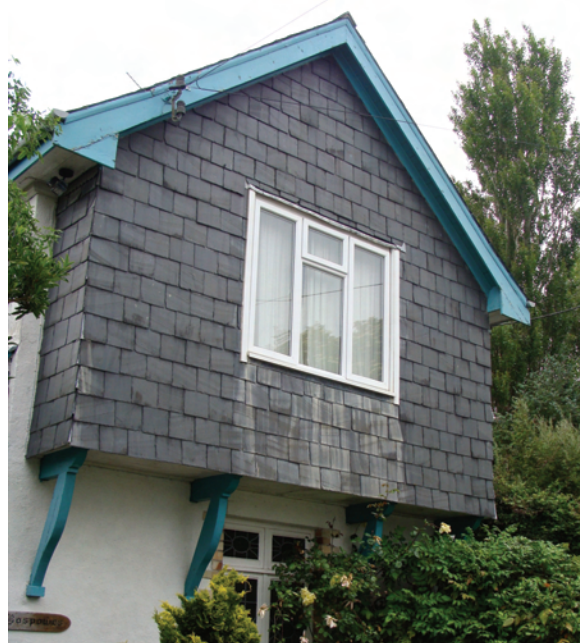
Although not extensive within the area slate hanging is dramatic where it does appear, such as here at Bospowes.

7.14 Tile hanging in the form of hung red clay tiles can be seen within the conservation area, most notably alongside mock timber framing on Craig-y-Don. Slate hanging also features, for example at Bospowes in Rumsam Close. These buildings represent isolated examples of these features, and although both could be said to be features common of Arts-and-Crafts architecture, they are not common within Rumsam. Indeed more historic buildings have surviving external shutters than have hung slate or tile. As such these features add to the variety of materials and construction techniques found within Rumsam but it would be wrong to over-emphasise their importance in the design of new buildings in the area.

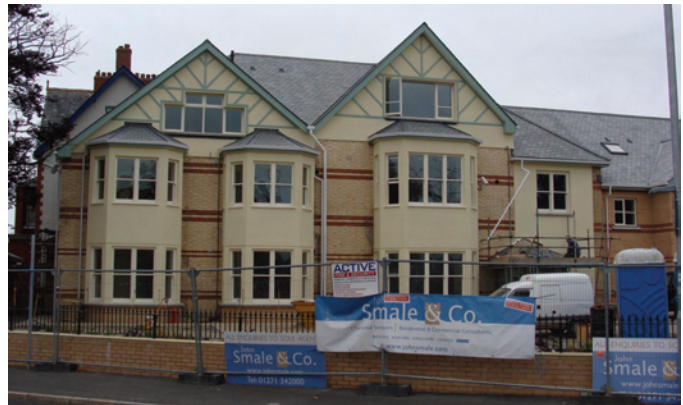
The rebuilding works following the fire at Lynwood House have replicated the style and material of the former building.

7.16 Several buildings have had additions and extensions over the years, the majority of which are in keeping with the buildings of which they form part. A recent example can be found at Lynwood House where a recent fire has been followed by the substantial re-building and enlargement of the property. Some elements of the building, particularly at the northern end of the property, have been retained and the new elements continue the design, scale and detailing of the historic portions of the property. As a result the largely re-built building makes a great effort in respecting its historic setting and the traditional materials of the surviving portions of the building. However, the unnecessary rendering of the bays and some other sections of the principal facade detract from this effort.

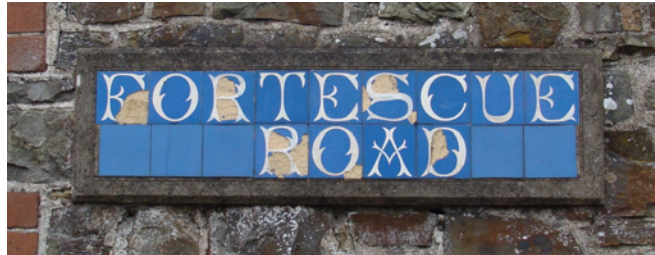
A blue encaustic tile street sign can be found within the proposed conservation area at Fortescue Road.

8.2 Examples of street name signs made up of blue and white glazed ceramic tiles can be seen throughout the Barnstaple area, with examples from Pilton, Newport and Rumsam also surviving, for example at Fortescue Road, and a Rumsam Road sign which is within the adjoining Newport Conservation Area. Despite having a thriving local pottery industry which could have provided such signs they were instead manufactured by Craven, Dunhill and Co. in Shropshire, which was established in 1874 and began producing alphabet tiles in 1875. Records of the Barnstaple Council Finance Committee show that payments were made in 1913 and early 1914 for 'blue letter tiles - £1 18s 6d and £1 8s 4d'. It is regrettable that the practise has not continued to recent times, although attempts are now being made to re-instate the tradition as a locally distinctive design practice.

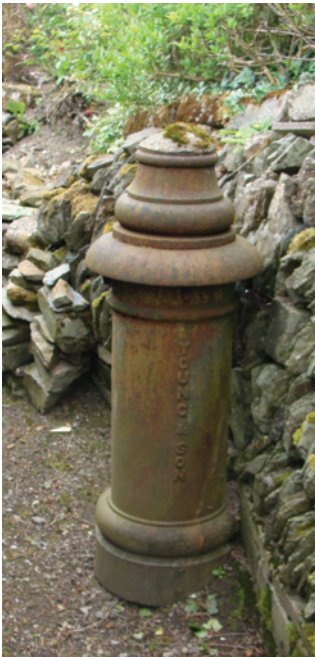
The surviving street lamp base on the footpath to Rumsam Gardens.

8.3 The only other survival of historic street furniture is an abandoned cast iron street lamp base located along the footpath which joins Rumsam Gardens to Rumsam Road in front of Orchard House. The lamp base does not appear to be bedded into the ground and may simply have been moved here after its removal from along Rumsam Road and then never taken away. This does serve to inform that prior to the modern standardised street lighting along Rumsam Road there were locally produced traditional street lamps installed.

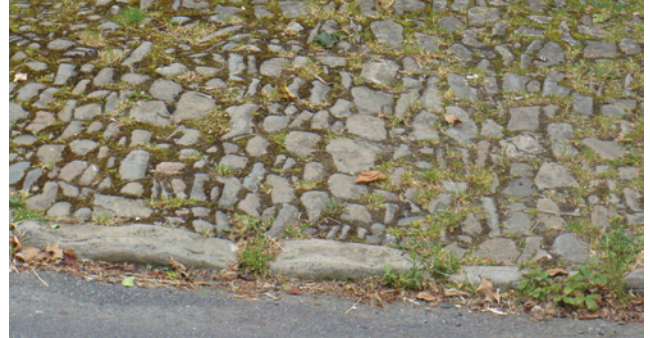
Cobbled street surfaces survive at the southern end of the proposed conservation area outside of Deerpark Cottage.

8.4 Surface treatments are largely a standard tarmac finish with concrete curbstones, however an isolated fragment of cobbled surfaces does survive in the pavements outside of number 2 Rumsam Road and the adjacent Deerpark Cottage. The streetscape is further enhanced by natural and soft landscaping in the form of hedges and trees, particularly where these are well kept so as to still allow views of the buildings to which they often form part of a boundary feature.
