## 1 Introduction

- This appraisal for the Fremington Quay Conservation Area was initiated in November 2009.
- The first designation of land found within the present conservation area boundary was by North Devon Council in November 1996.
- This appraisal will replace an earlier appraisal for the Fremington Quay Conservation Area completed in August 1997.
- The completed appraisal, along with the suggested boundary changes, was adopted and became effective in December 2010.

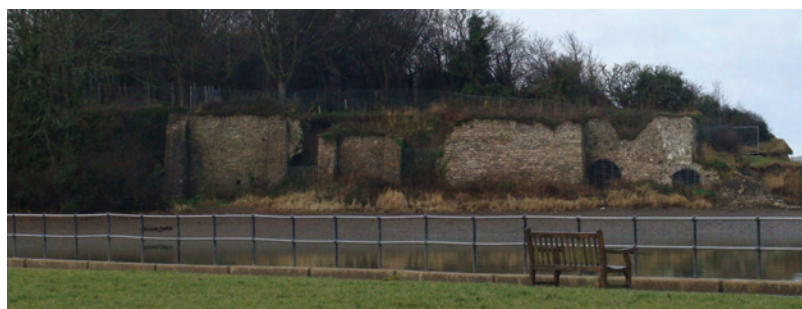
**The view out to the listed limekilns from the western end of the quayside. Safety fencing can be seen at the high points of the site as well as blocking the kiln mouths.**

**5.4** The kilns now stand in a poor condition with no access to their upper areas, where raw material would have been stored and loaded into the kilns themselves, due to safety concerns. The openings at the lower level, for removing the finished lime, are blocked by modern steel grills to prevent access to the structure. The exterior masonry is in a reasonably stable condition, with pointing and stonework in good condition, except for above the central kiln opening where the masonry above the arch has collapsed. This gives the kilns the appearance, from a distance, of a romantic ruin of the industrial age.

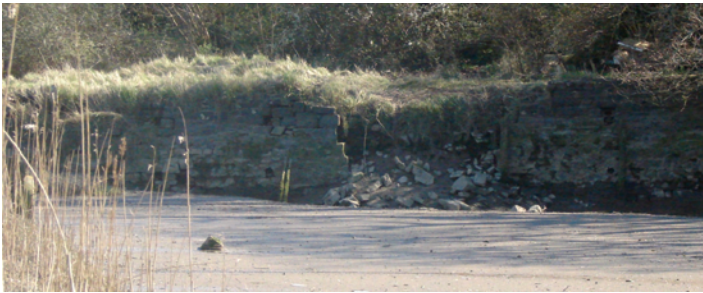
**The remains of the retaining wall at Fishley Wharf are visible on the opposite bank.**

**6.9** From here the remains of Fishley Wharf are also visible on the other side of Fremington Pill, some portions of the old Quayside wall still stand although some areas have collapsed. Stumps of timbers can be seen in the surrounding silt indicating that additional timber structures were once associated with the stone quayside here.

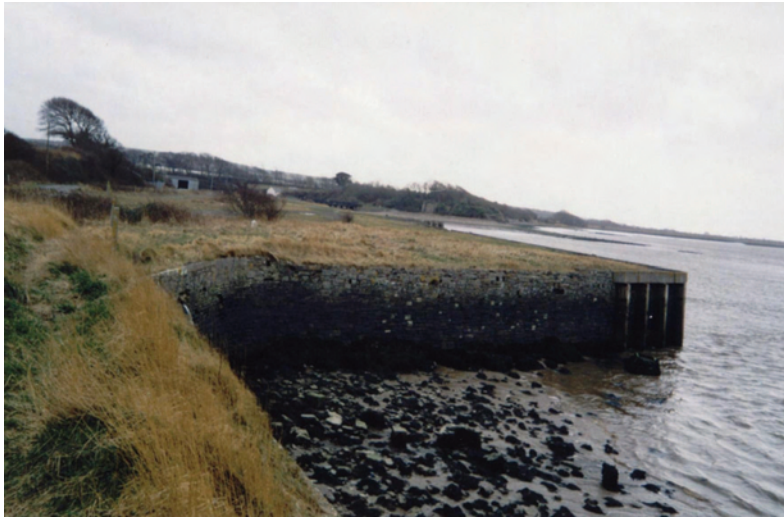
**The quayside had no barriers and the overgrown, dilapidated appearance of the area, where flytipping and unauthorised camping were problematic together with access difficulties led to the area being underused.**

**8.2** Much of the area was covered in concrete which was beginning to break up as vegetation became established in the various cracks within the concrete surface. Much of the quayside had no railings or barriers, although some areas had wire and barbed wire fencing.

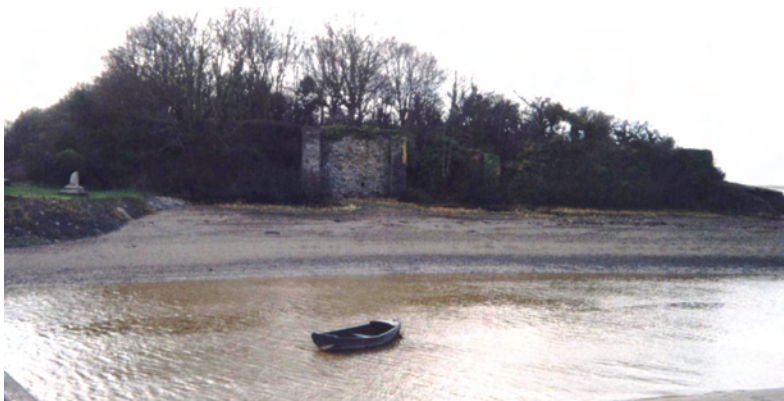
**Although the limekilns remain in poor condition they are much improved from their 1997 state.**

**8.4** Vegetation has since been cleared from the limekilns at the west end of the site, fencing barriers prevent access to the unstable interiors of the structure and low level vegetation, such as ivy, has been cleared. Some repair work to the structures has been

undertaken so as to stabilise them, with slightly more extensive work to the listed kiln (left hand side in this image). Even so access to the elevated area, where loading of the kilns would have been undertaken, is still prohibited for safety reasons.
