1 Introduction

- This appraisal of the Putsborough Conservation Area was initiated in January 2009.
- The first designation of land within the present conservation area boundary was by North Devon Council in November 1975.

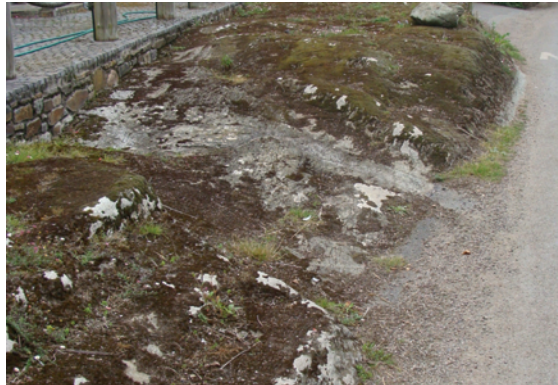
The local slate and shale bedrock is never far below the surface and can often be seen above ground in outcrops such as this

5.3 Within Putsborough and the surrounding area the bedrock, of local slates and shales, is never far below the surface and in places within the conservation area the bedrock is visible at the surface. As a result many of the local vernacular buildings are constructed from a mix of this local slate and cob.

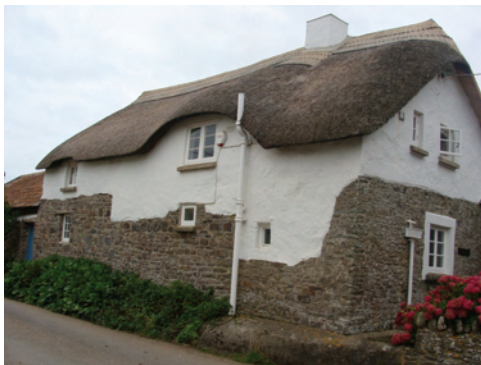
The Old Cottage demonstrates the typical construction method of tall local stone bases and rendered cob for the upper portions of walls

7.4 The majority of the dwellings are constructed with stone wall bases and rendered cob as at The Old Cottage, Manor Farm Cottage and Putsborough Manor. These buildings, together with the farmhouse at Manor Farm have thatched roofs, although some sections of their roofs may be of slate, such as the curved link and entrance at The Old Cottage.

7.6 The construction of the buildings with stone walls at the ground floor level and cob above is a common feature in cob buildings. In order to protect cob from damp it is rarely built straight from ground level, and the height of the stone plinth is often dependent on the extent of the eaves overhang of the roof. A larger overhang often results in a shorter plinth as less rainwater is likely to splash back and wet the cob. Although thatched roofs often have a greater overhang than slate or tile roofs the overhangs within Putsborough are not overly large, probably explaining why the stone walls often extend to ground floor ceiling level. In this way the stone walls also take the weight of the floor joists for the first floor.

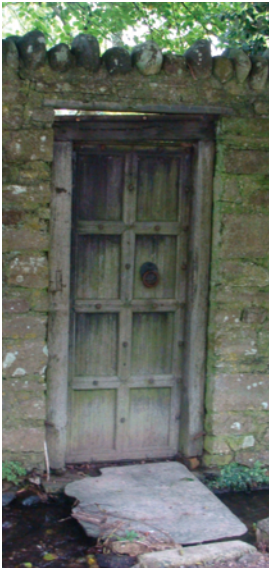
The Jacobethan door in the boundary wall to Putsborough Manor

7.10 Putsborough Manor dates to the early 17th century and possesses features typical of this period, such as chimneys located on principal elevations of the building (albeit now enclosed by a later addition) as decorative features or demonstrations of wealth. The Manor itself is odd in that it is physically connected to barns and out-buildings, where as high status buildings most typically separated themselves from subservient agricultural buildings. The timber door through the boundary wall, near the ford on the southern property boundary, dates from the 'Jacobethan' period (1558-1625, covering the reigns of Elizabeth I and James I) and is probably contemporary with the building of the Manor House.

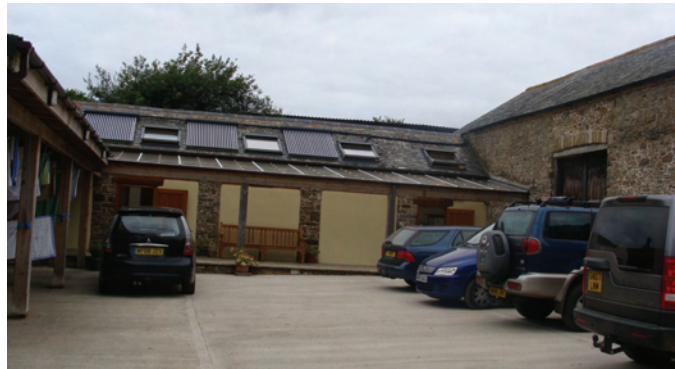
The north range of the Manor Farm barns demonstrates the adaption of a farm building so as to give it a sustainable future use and ensure its maintenance

9.2 As a predominantly farming settlement the hamlet is affected by changes in modern farming. Redundancy or near-redundancy of outbuildings is a particular issue and for these buildings to justify expenditure for their maintenance creative new uses need to be found for them. In many cases this may require a degree of change to be accommodated. An approach which secures a viable, and sustainable, future use for otherwise redundant buildings with the minimum need for change to the fabric of that building will be looked upon positively. Examples of this sort of adaption and re-use of existing buildings can be seen in the laundry and personal ablutions facilities provided for use of campers in the north range of the Manor Farm stable courtyard.
