## 1 Introduction

**1.1** Conservation Areas are designated by Local Planning Authorities under the Planning Acts. Section 69 of the Planning (Listed Buildings and Conservation Areas) Act 1990 defines a Conservation Area as :

**2.1** The conservation area at Landkey Newlands was formally adopted in September 1987 and covers an area of 17.9 hectares or 43.3 acres (reduced from 21.8 hectares, 53 acres). There had been no review of the boundary undertaken since this initial designation until 2012.

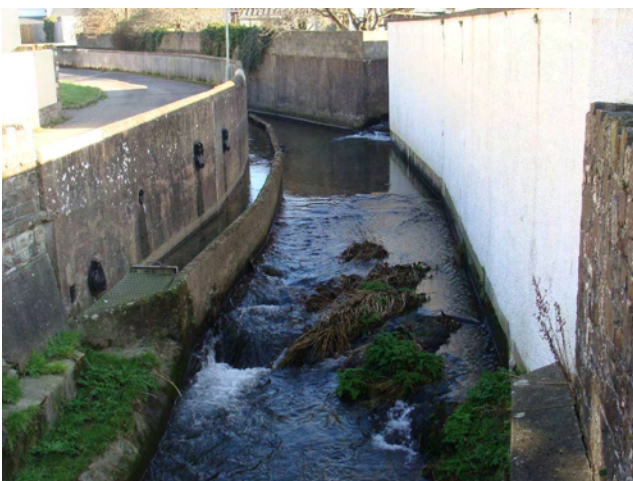
**The valley location and abundance of running water and springs made Landkey Newlands ideal for water powered mills, as the surviving network of leats testifies.**

**5.5** Views along one of the mill leats are possible from the bridge at Tanners Road, as they are along Mill Road. The stone faced retaining walls which form the channels to the leats reinforce the man-made character of these waterways.

**6.16** The various surviving mill leats provide an important contribution to the character of the village, not only with their visual impact and their appearance on plan which helps to locate the sites of former mills, but also in the sound of running water which becomes most prominent along Tanners Road and Mill Road and the junction between the two.

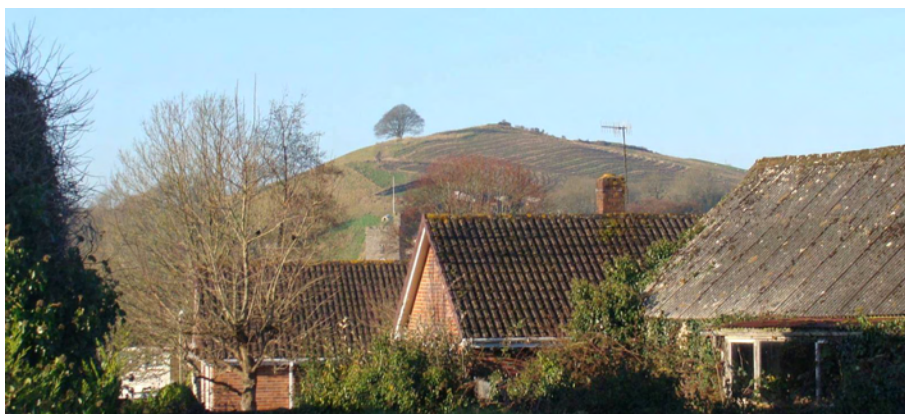
**The hill near Hill Farm stands out as a landmark that can be seen from several vantage points along Blakes Hill Road, and the tree near the top of the hill is also a prominent feature.**

**5.2** Views to the West, along the length of the valley, are occasionally rewarding where a prominent hill with a tree near the top of its Southern slope can be seen as a prominent landmark. Again this hill can be seen from the Eastern end of the conservation area where Blakes Hill Road is at a higher level.

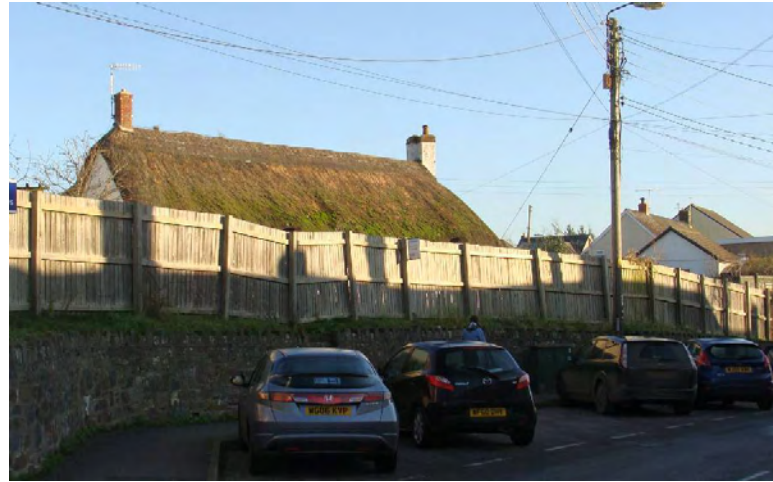
**Thatch End and Wallabrook Cottages should occupy a prominent visual position, but instead they are hidden behind bland timber fencing.**

**5.6** At the junction with Ackland Road and Blakes Hill Road stands Thatch End and Wallabrook Cottage. This thatched property occupies a dominant corner position on elevated ground which should

give it a striking landmark position within the streetscene. In reality most views from Blakes Hill Road are blocked by the shiplap fencing enclosing the property boundary of the infill development at The Firs. This building is more prominent thanks to its additional height, however it is of vastly inferior architectural quality. The provision of privacy for a piece of modern infill development and its driveway has robbed the village of a historic landmark property which is now sadly hidden from most public view points behind a poorly detailed boundary treatment.

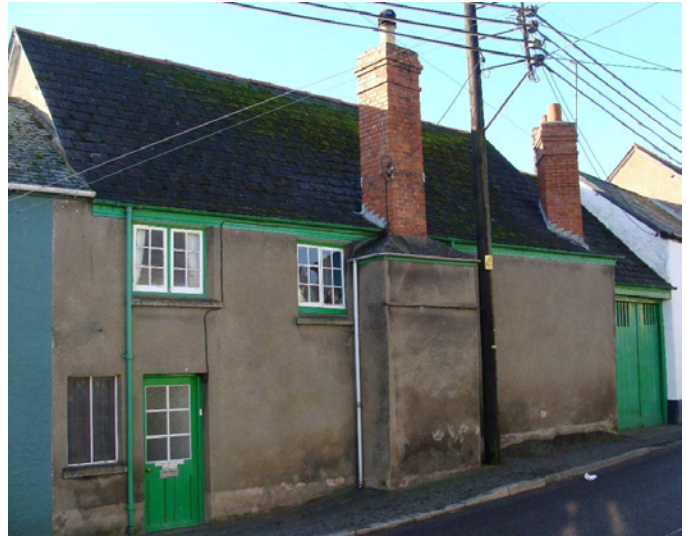
**Ratcliffe (Grade II Listed) has a large axial stack chimney (upper part re-built) which dominates its frontage; it also has an unusual corner chimney at its West end.**

**6.1** Along the relatively short length of the conservation area's main street, some 900 metres (0.56 miles), there are 10 properties which feature axial chimney stacks. These are a type of chimney where the stack is located along the main external wall of the property, usually beside the main entrance door. Such a large number of these features surviving in a relatively small area is unusual. The distribution of properties with axial chimney stack is shown in Appendix 3(V).

**6.2** In a chronological sense these types of chimney are early, typically dating to the late 16th or early 17th Centuries in Devon. The stacks usually projected outside of the building, primarily so that they made a prominent feature and also so that they did not intrude on the internal floorspace. When chimneys were a new concept those who could afford to make the modifications to their property to have them wished to ensure that everyone noticed. The most prominent position, on the front near the door, was selected so that every visitor could hardly fail to spot the expensive new chimney.

**6.3** Often seen on the same property as these axial stacks (although they can also be found on a few properties without axial stacks) is another unusual form of chimney, located at a corner of a property and also twisted 45 degrees to the lateral and gable walls of that property. Chimneys in similar positions can be seen on some older thatched properties in Chulmleigh, but these are not set at an angle like those seen in Landkey Newlands. Nearby Swimbridge also has a significant number of axial stack chimneys, but none of the more unusual corner chimneys.

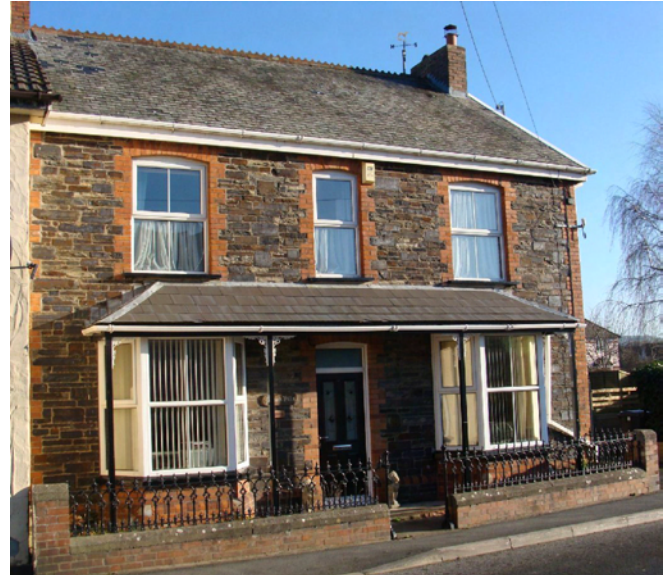
**Brook Villa is one of only a small number of properties which feature the use of brick. It is also one of the few Victorian properties within the conservation area.**

**6.11** Cob is also evident, again rendered over for protection from the elements. Brick is not a common feature within the conservation area and is practically limited to Chapel Terrace, with Marland Brick window detailing, and a semi-detached pair of houses opposite which exploit the high Victorian polychrome style in a mix of Marland and red bricks. Brook Villa also makes use of brick detailing as quoining, detailing around windows and doors, and the plinths of the bay windows.

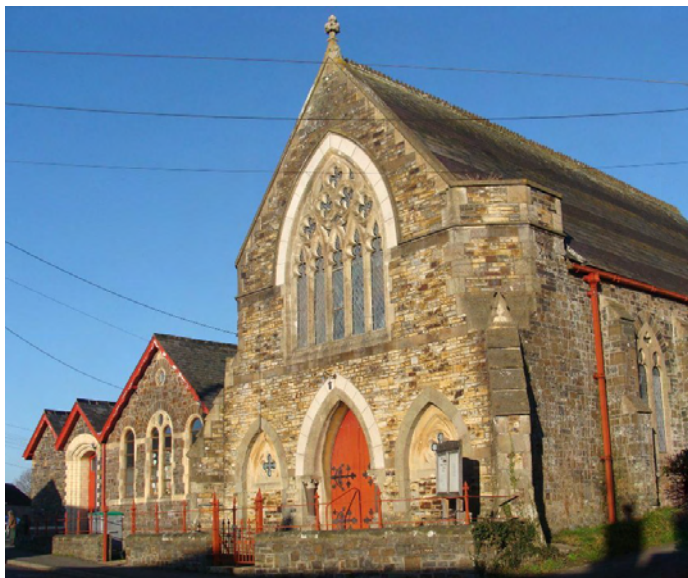
**Landkey Methodist Church (1868) is a dominant and imposing landmark building, together with its former Sunday School, at the West end of the conservation area.**

for worship. The church itself is of Geometric Decorated Gothic style featuring groupings of quatrefoils in its largest windows and single quatrefoils at the heads of the aisle windows. The schoolroom is lower and of slightly more simplified design. Here doors and windows have round headed arches instead of the pointed ones seen on the church. Quatrefoils are replaced by punched circles giving a much plainer and less intricate appearance. The walls of both are constructed of local stone, but the dressings around openings and as string courses are of a finer imported stone, possibly Bath Stone. Weathering of this imported stone banding is different between the two buildings and might be from two different sources.

**6.12** The Methodist Church and its associated Schoolrooms are some of the few examples of 'formal' architecture within the village, other examples being Brook Villa, Challacombe House, Chapel Terrace and The Redbrick House. Many of these examples are clustered at the Western end of the conservation area.

**6.13** The church and schoolrooms are good examples of Victorian Gothic Revival Architecture. The first Methodist Church on the site was built in 1816 and may have been a modest building, but it was replaced in 1868 with the current church which has recently become redundant and is no longer in use

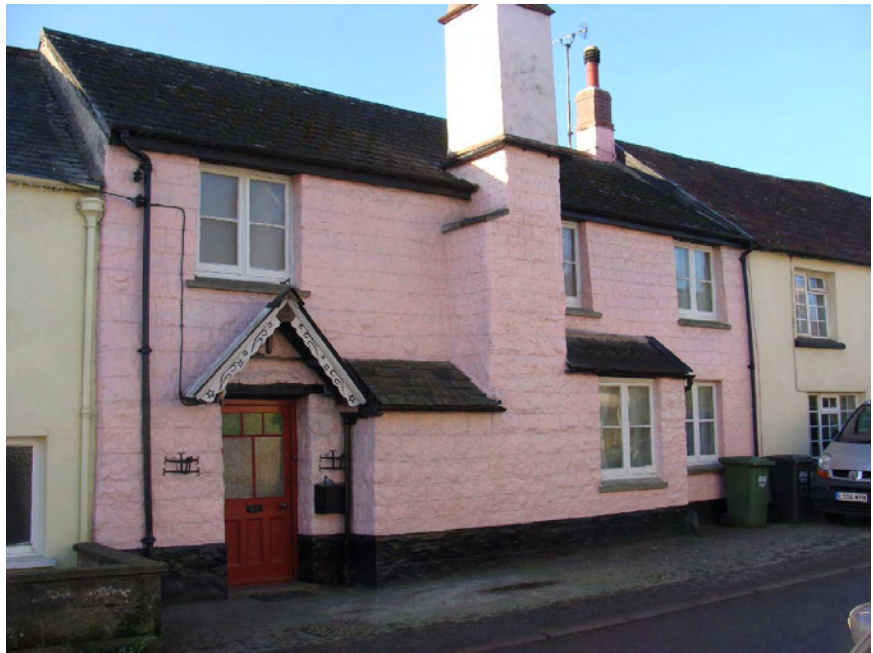
**Works that do not require planning permission on unlisted buildings can have a huge impact on the appearance of a building and its neighbours. Crude textured finishes can be particularly harmful to the character of a property.**

**8.3** A demonstration of the harm that can be done by permitted development works can be seen at Ward Cottage. The property is an example of a late 16th Century property with large and imposing axial chimney stack, the upper part of which has been re-built in the mid to late 18th Century. The building has been treated with a thick coating of cement render which is now cracking in places allowing water to penetrate into the

fabric of the building. Lime render would be able to accommodate the small movements of the building without cracking, while the stronger but more brittle cement simply resists movement until the point at which it cracks apart.

**8.4** The surface finish of the render has been given a series of incised lines intended to replicate large and squared ashlar stone blocks. Unfortunately there is no consistency to the lining which appears to have been done freehand and in a hap-hazard fashion. There is no traditional basis for such work and the properties which do feature this technique have sharp and straight incised lines on flat walls to provide an often convincing visual effect. This is, by comparison, crude and distasteful. It is possible that the justification is that such work looks 'rustic' and that, as an old building, crude finishes are somehow appropriate. The truth is that traditional buildings were usually well constructed, and those built well enough to survive over 500 years to the present day were far from crudely built and finished. Overall the choice of render material, the way in which it is finished and the colour in which the property has been painted are all inappropriate to the property and together serve to have a detrimental impact on what should be a landmark historic building within the area.
