Contents

1 Introduction

2.1 The Witheridge Conservation Area was first adopted before 1974 by Devon County Council, and the boundary was last subject to review in November 2012.

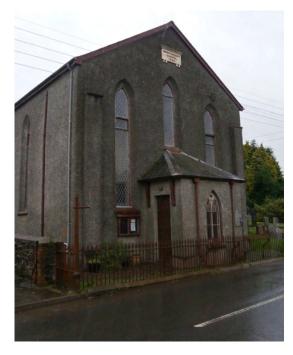
Witheridge Congregational Church on Fore Street.

4.10 Increase in 19th Century non-conformist religion is evidenced in the history of Witheridge. A Congregational Church was opened in 1839 and registered for Marriages in 1845. In 1845 a Chapel School was opened near The Square, before being relocated adjacent to the church in Fore Street in 1898. The Manse was erected in 1854. In 1855 Methodism arrived in Witheridge, with a barn

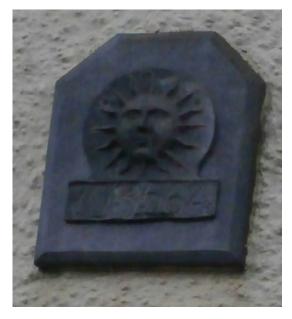
The fire insurance plaque seen on 36.11Fore Street.curvit

also features a lead fire insurance plaque above the front door from the sun Alliance Fire Insurance Company; the identifying number below the sun emblem is just visible as 403564.

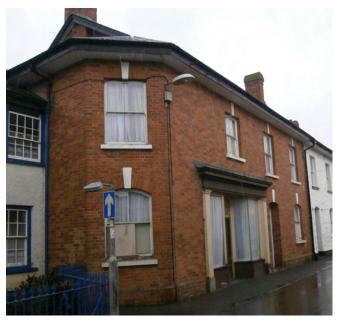
6.22 Number 3 West Street itself is one of few exposed red brick properties within the village and forms a significant contrast to its neighbours. The bricks used here are a soft natured brick with a pale orange/red pastel appearance, tightly jointed showing some high degree of skill on the part of the builders. All window openings are headed by rubbed brick vousiored arches with white painted keystones; those on the upper floor are flat arches, while the ground floor has segmental round arches. Half of the frontage had previously housed a shop and retains a traditional late 19th Century shopfront with stallrisers and a recessed central entrance door flanked by plate glass display

3 West Street is one of few exposed brick buildings in Witheridge.

windows. The neighbouring number 5 West Street appears to have the same construction and was part of a semi-detached pair. Unfortunately number 5 has had its distinctive brickwork painted white. This is almost certainly irreversible and judging by the condition of the brickwork at number 3 was a purely aesthetic choice rather than a requirement to protect the fabric of the building.

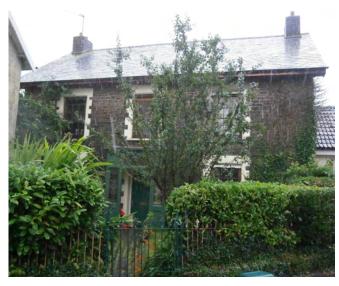
10 West Street has experienced fewer alterations than its neighbours along the North side of the street.

6.25 By contrast the neighbouring number 10 West Street has had few external alterations. It retains a natural slate roof and a glazed timber porch featuring etched glass panels. Although of some age the porch itself is unlikely to be an original component of the building, however its design and proportions have been well considered and it forms a positive addition to the building to which it is attached. Window and door openings are surrounded by rendered panels to create a quoining effect, which is then painted white in contrast to the very dark exposed stonework from which the walls are constructed.
