1 Introduction

2.1 The Bishops Tawton Conservation Area was first designated in August 1989 and has not been subject to review since that first designation; now almost 24 years ago.

3.1 The Bishops Tawton Conservation Area was first designated in 1989, and covers an area of 13 hectares (32.1 acres) along the east side of the River Taw; increased from 12.5 hectares (30.9 acres) prior to the 2013 boundary changes.

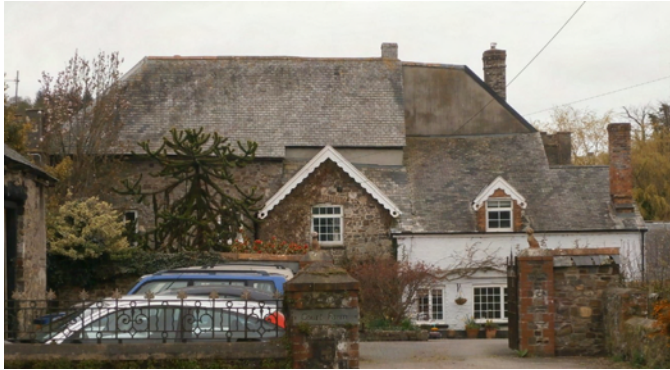
Court Farm incorporates parts of the 15th century Bishop's Palace.

7.8 South of this is Court Farm, labelled on maps as 'Remains of Episcopal Palace'. Parts of the main house date back to the 15th century and are fragments of the Bishop's Palace which stood on the site at that time. Over the years the building has been altered and added to, with features such as the decorative corner turrets dating to the very start of the 19th century, with other features such as dormer windows and forward facing gables with decorative barge boards dating from a slightly later period. As such the appearance of the building, particularly from the roadside, fails to adequately convey its true age or origins upon a casual inspection.

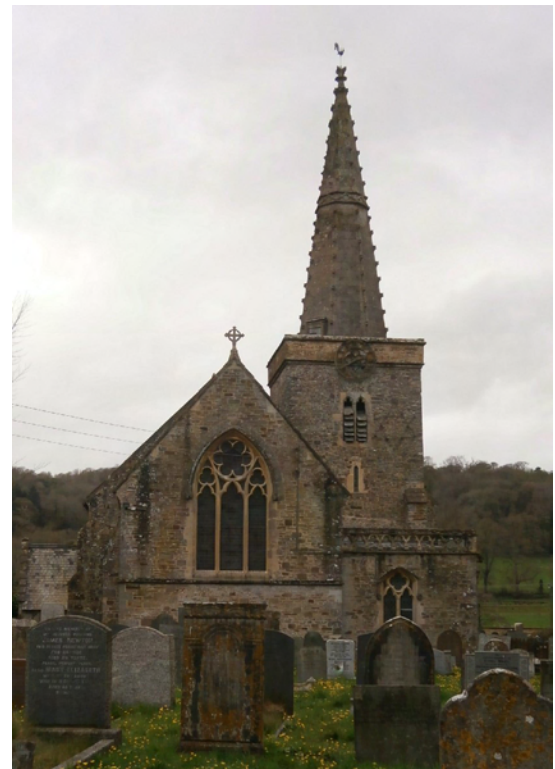
The parish church is the oldest structure in the village today.

7.4 The Parish Church is the oldest of these, with identifiable fragments dating to the 14th century and almost certainly having older masonry concealed within the existing structure. The church sits not at the highest point in the village, but at the highest point to the west of the main road with its churchyard accessed via steps and clearly elevated above neighbouring properties. The parking area in front of the churchyard, separated from the road by a low stone wall appears as if it was once a more formal approach to the church, although in reality it is a recent creation associated with the widening of the A377 and creation of New Road. The road immediately north of here was narrow and land was taken from the east (Coach House, formerly the village post office) to widen the carriageway. This left the area beside the church much wider and the wall was constructed to delineate a more regular width carriageway.

7.5 The church is of similar style to that at nearby Tawstock, although its tower sits over the north side of the building rather than centrally over the crossing as at Tawstock. The tower is also topped by an octagonal stone spire which is a unique feature in the county and was probably intended to be a display of the wealth and power of the diocese.

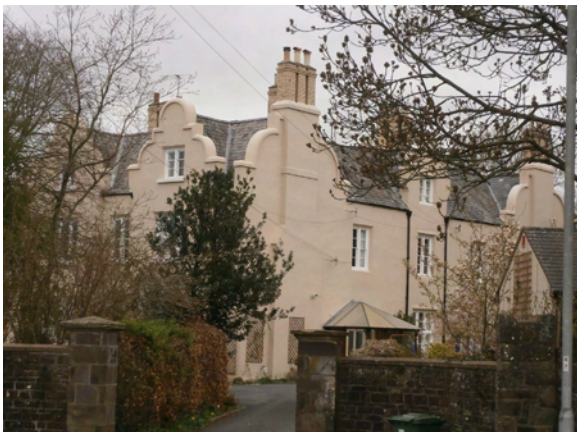
The Old Vicarage with its decorative gables stands opposite the church.

7.11 Opposite the church we find its former vicarage (now 3 houses), an 1841 late Tudor style building by John Hayward (who also designed St. Andrew Exwick, Tipton St. John, Bicton new Church and St. James at Ilfracombe) who was a student of

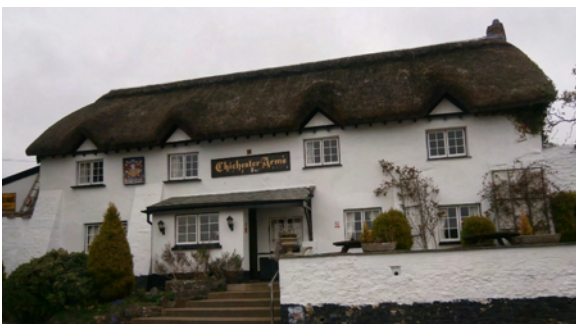
The Chichester Arms dates to the 17th century but had to be extensively repaired after a fire.

7.21 The Chichester Arms is on the corner between Village Street and East Street and is a large early-to-mid 17th century building. The building has an axial chimney stack on its rear elevation, now mostly enclosed within a 20th century rear extension, and this is a tell-tale feature of 17th century buildings in this part of Devon. The building was extensively altered during the 19th and 20th centuries, including having its internal layout changed to produce a near symmetrical arrangement of rooms which is certainly not original. The building also suffered a major fire in 2005 following which it has been repaired and re-opened. Externally there is little obvious sign of this catastrophic event.

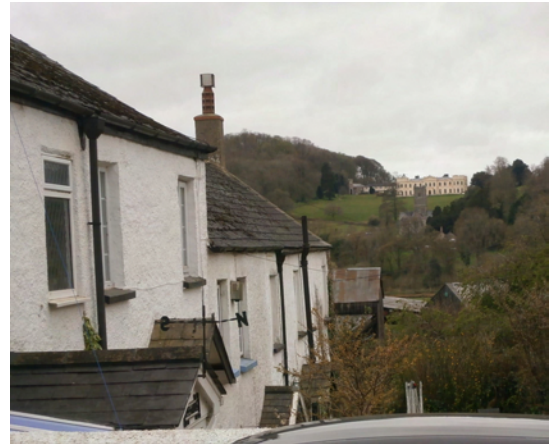
The view along Springfield Terrace with its stepped roofline and Tawstock Court in the background.

7.22 Further south and opposite the Chichester Arms is Springfield Terrace, another short terrace of 4 houses which run at right angles to the street and accessed via a narrow pedestrian lane at the front of the properties. The terrace is stepped in the middle as it is built on sloping land. This does make the roofs of the properties very visible, with their red clay ridges and artificial slate roof coverings. It would appear that original windows were twin light 8 pane-per-light side hung casements as survive on numbers 3 and 4, with replacements of varying sensitivity on numbers 1 and 2. Unfortunately the property closest to Village Street (and most visible from the public realm) is also the most significantly, and least sensitively, altered. These changes include uPVC windows with mock lead effect and top hung transom lights. The stone sills have also been replaced with uPVC window sills, the new windows fitted near flush with the walls resulting in the loss of deep window reveals seen on other houses in the row. The window openings have been made wider, the open porch replaced with a wider enclosed porch and an additional front facing extension added to the side of the porch. Beyond the first property in the row the remaining 3 hang together well as a group and viewed together with their modest front gardens create a pleasing view off of Village Street. A view straight along the front of this row also happens to line up with a view across the river to Tawstock Court and Tawstock Parish Church.

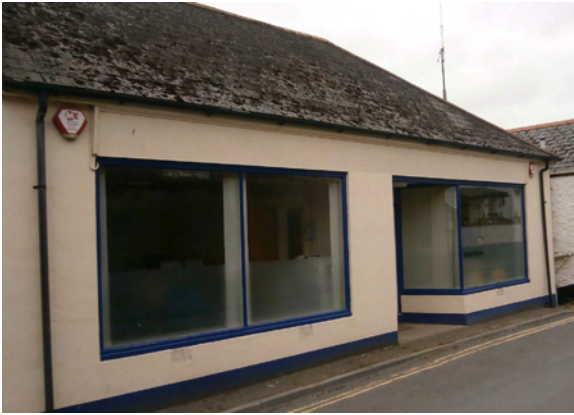
'The Stores' with its large glass display windows is out of character with other buildings within the village.

7.23 To the south of this terrace is "The Stores" now in use as offices. The heavy-handed and expansive 1970's display windows do not lend themselves to a view of an office and indeed produce an appearance greatly out of character with any other building within the village. This being said it is also the only commercial property within the village and its different function would necessitate a different character. Besides the large expanse of glass the building is rendered beneath a pitched slate roof, just like many other buildings within the village.

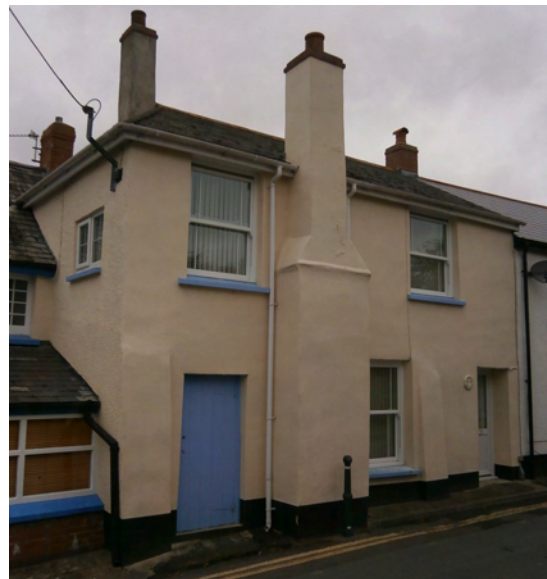
1 Homelea Cottages with its forward facing axial stack chimney.

7.24 Next door to the south are a pair of cottages, 1 and 2 Homelea Cottages, which are the oldest buildings in the village excluding the Church, The Chichester Arms and Court Farm. These cottages date to the early 17th century as indicated by the axial chimney stack on the frontage of number 1. Both have been altered, principally through the introduction of large sash windows in the Georgian period which have subsequently been replaced with uPVC sliding sash units. It is also likely that both properties were originally thatched, although the roof slope is inadequate so if these were originally thatched cottages then the roof structures must have been replaced in the past.

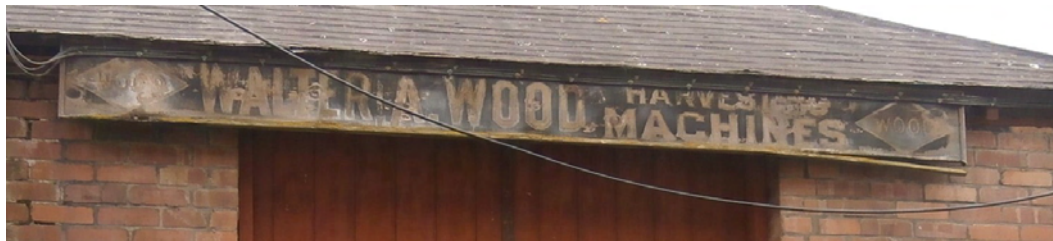
The agricultural engineering works of Walter A Wood are a lone example of rural industry within the village.

7.30 Next door is the old engineering works of Walter A. Wood, manufacturer of agricultural equipment and 'harvesting machines'. The engineering workshops are a red brick building with large arched window openings and a highly glazed timber clad outshut to the south side to provide extra floorspace and to provide light. The building features sliding timber doors for easy access for large equipment, an old faded advertising sign for the company on the roadside gable, also featuring a further pair of arched windows below a large first floor loading door.

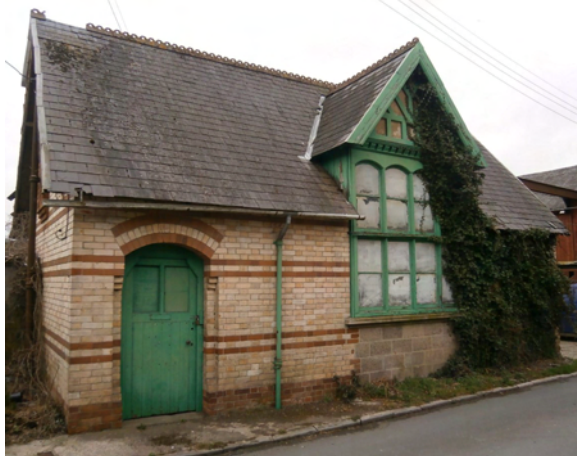
The former reading room associated with the adjacent engineering works.

7.31 This building is separated across a courtyard from another, more ornate, building in red brick and marland brick, almost in the style of a Victorian chapel with polychrome decoration, and decorative dogtooth courses of brickwork. The building was formerly a reading room, funded by Walter Wood's company for the benefit of his workers and the wider community. The building is connected to the workshops via a large 'I' section steel beam running overhead which would have held lifting and loading equipment. The buildings are sadly disused although they make a significant contribution to the character of the street and have great value as examples of the small scale engineering industry that existed at one time across the country and the wealth and philanthropy which went along with it.
