1 Introduction

2.1 This assessment of the North Molton Conservation Area was begun in May 2013 and included both an inspection of the existing conservation area and its surroundings and archive research into the history of the village.

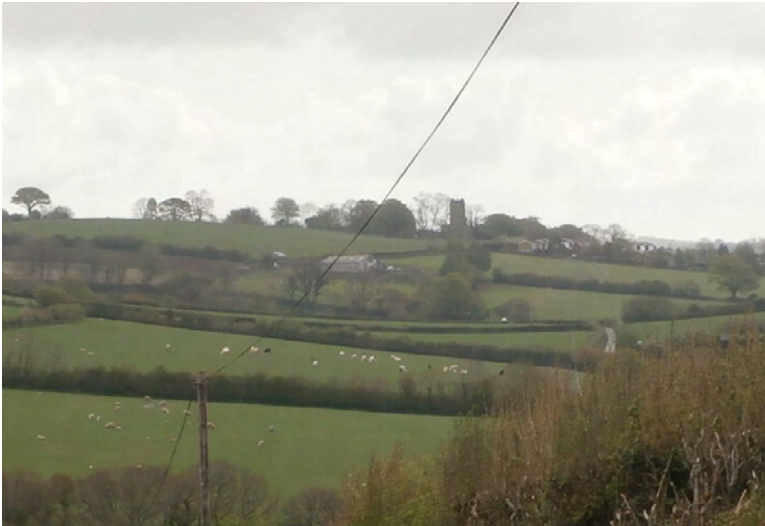
The tower of the Parish Church is the most prominent feature of the village, visible silhouetted on the horizon from the west.

6.1 Views of North Molton from the surrounding landscape are often striking, with the Parish Church near the high point of the ridge particularly prominent in views from the west, south and east. One such view is from the west on Stoneybridge Hill; views from this angle allow the tower of the church and the rooftops of the village to stand out against the horizon on the southern slopes of a hillside. Views from the east towards Lambscombe and Millbrook allow the village to stand out in a similar way.

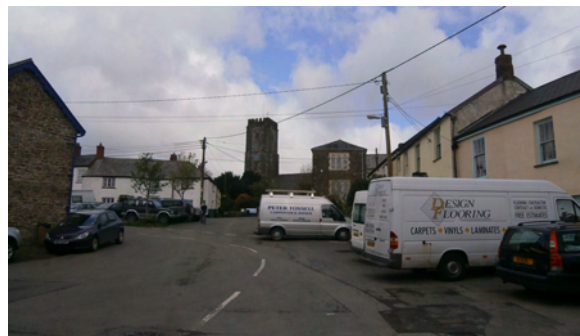
The view from the south across The Square shows its open nature with the Parish Church as a focal point beyond.

6.3 Within the village itself the open space of The Square provides the focus of most views as well as being located at the centre of the village. The space was almost certainly laid out, or cleared, shortly after the charter of 1270 which gave permission for the village to hold a market. The area is in the location typical for medieval market places, being immediately outside the lychgate entrance to the churchyard. The space is, however, a degree larger than might be expected for a medieval market place and was probably enlarged during the Georgian period in an effort to create a more formal square.

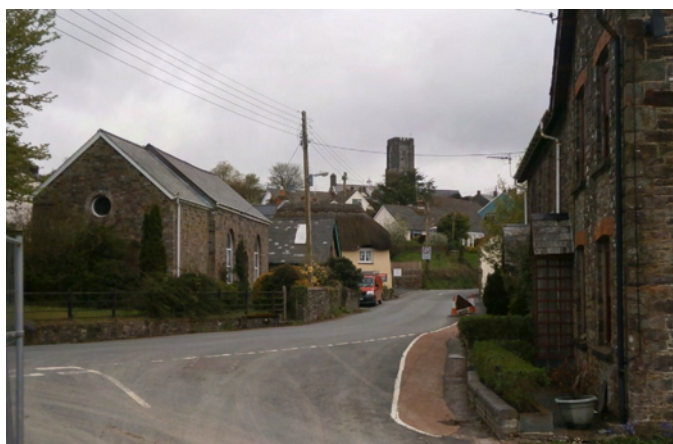
The view from the southern end of Fore Street with the old Wesleyan Chapel in the foreground and the tower of the Parish Church beyond.

8.18 On the opposite side of Fore Street stands a former Wesleyan Chapel, now converted to residential use. The stone built chapel has a small ocular window high in its southern gable wall, with simple Gothic style pointed window openings in its side walls (windows now replaced with domestic style mock leaded units). The church

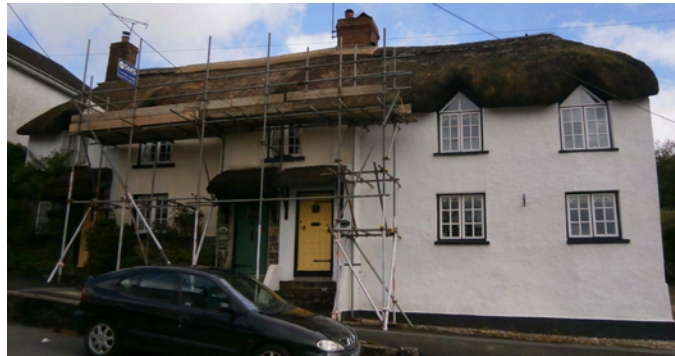
Higher Locks and Winston Cottages stand at the eastern edge of the conservation area and are one of the few thatched properties in the village.

7.2 The eastern edge of the conservation area begins to the east along East Street with 2 & 3 Higher Locks Cottages and Winston Cottage, a short terrace of three thatched cottages on the north side of the road. The pattern of glazing is of two light casements, each made up of 6 individual panes of glass. The thatch is lifted above each of the upper floor windows to form characteristic 'eyebrows' and in the case of Winston Cottage the upper floor windows have been extended and enlarged through the additional of a triangular overlight which projects into the eyebrow. Each doorway is accessed via stone steps and each front door has a projecting hood.

7.3 Although thatched roofs are far from typical within the village and its conservation area they do appear on several properties. These first cottages do, however, set the construction standard for the village, being of rendered rubble stone and cob as are the majority of the properties in North Molton.

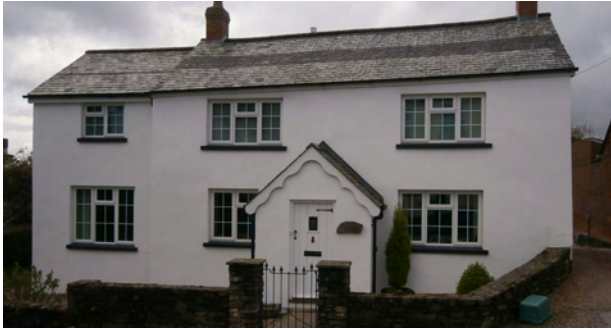
Fern Cottage is a typical rendered cob cottage, its most striking features being the modest front garden area and the polychrome roof slates.

7.5 To the west of Pullens is Fern Cottage, also in rendered cob and stone but on a slightly smaller scale, with a two storey extension to the east gable end. The polychrome decorated slate roof is perhaps the most striking feature of this property, with a stripe of darker grey slate through the central third of the roofslope which also features a band of fishscale slates. This structural decoration adds to the character of the building, while the extension to the left side is well designed and proportioned to respect the main house whilst also being legible as an extension.

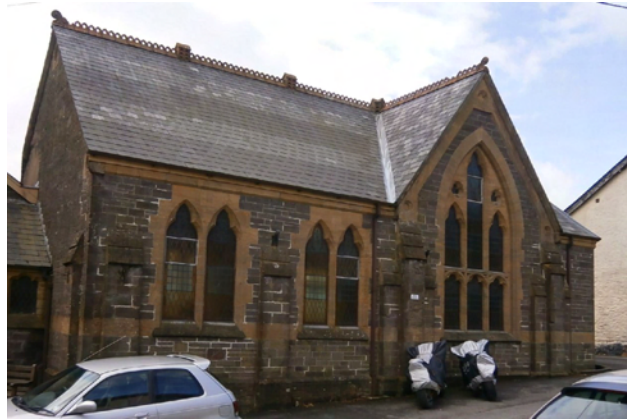
The Methodist Church was opened in 1891 after the congregation outgrew the chapel built in Fore Street in 1836.

7.8 More generally along East Street there are a few examples of formally designed buildings, including the Methodist Church and church school, both in the Victorian Gothic Revival Style and built of a dark brown ironstone with lighter biscuit brown stone window dressings. Like Fern Cottage the church roof has bands of coloured slates to provide a scheme of polychrome decoration, the ridge having large decorative ridge tiles and breather vents.

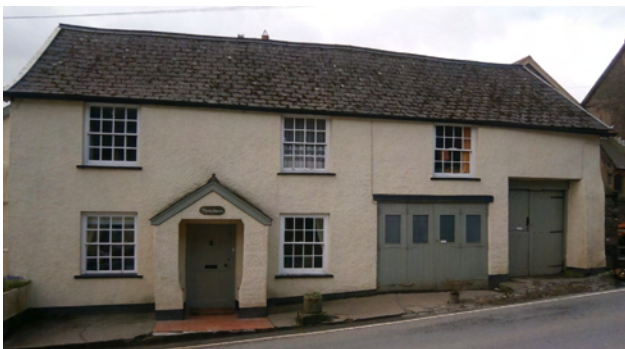
Thorne House is a good example of a former village centre farm, still retaining an access passage to a rear yard, now with folding garage doors.

7.10 There are a number of former farmhouses along the street, including Thorne House where it would appear that the right hand side of the house was formerly a barn with either accommodation or hay lofts above. The large openings to the side of the building with large timber doors and timber bi-fold doors would have provided access to the barn and probably passage through to the rear via a second set of doors in the other side of the building. The bi-fold doors are probably a later addition with the opening created to serve as a garage or workshop.

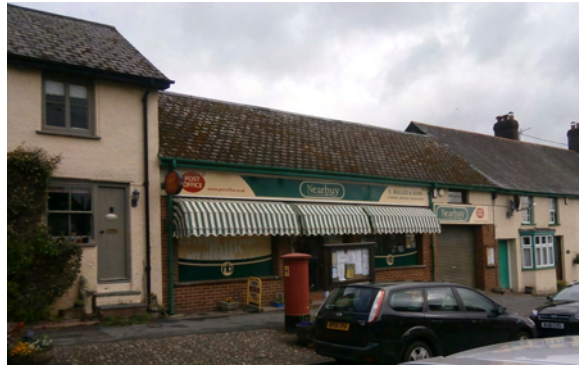
The village shop is of atypical materials, being of red brick rarely seen in the village.

7.17 The post office and village shop with its modern dutch awnings, red brick construction and expansive glass display windows, largely obscured by applied vinyl signage robbing them of their display function in any case, is another modern intrusion which has little regard to the buildings that form its setting and fails to make a positive addition to the character or appearance of the area.

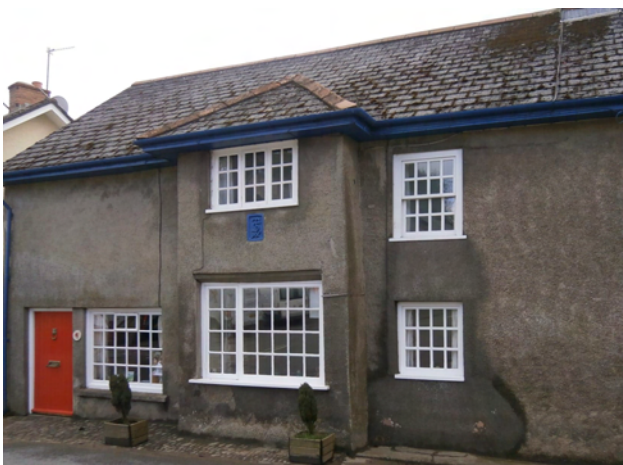
Red Lion Cottage, with woolmark on projecting bay, was built no later than the early 17th century.

7.20 Next door are Red Lion Cottage and Davreen; this pair features an interesting carved stone 'woolmark' on the projecting bay at Red Lion Cottage. The wool mark was that of Thomas Parker, a local wool stapler. Staplers were part of a guild with a royal monopoly on export of wool to the continent, selling at a fixed price determined annually. The marks allowed customs

officials to trace which merchant had sold which wool. Besides this the house itself is rather bland for a wealthy wool merchant. There used to be evidence of additional timber mullioned windows and it is possible that the building once had a much grander appearance.

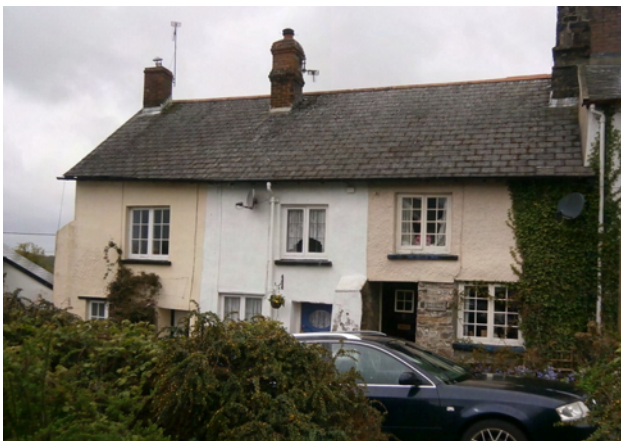
The modest cottages enclosing The Square along its west side are a marked change from the larger properties along the other sides and were probably labourers' cottages.

7.23 1 & 2 Locks Cottages together with Swallow Cottage form a group of 3 terraced cottages on a very modest scale, probably originally 1 up 1 down. Each has a single window on each floor, of 6 or 8 pane 2 light casements. These were easily amongst the lowest status dwellings in the village when built (early to mid 18th Century) and it is odd that they form such a marked contrast with the relative formality of the rest of the houses facing The Square. The buildings are in conformity with typical local materials, stone or cob with a lime render and a slate roof.

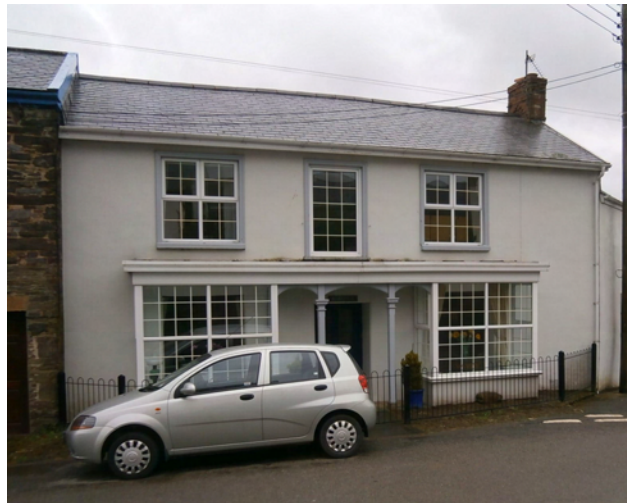
Blakesville is a good example of one of the higher status properties enclosing The Square, its symmetrical Georgian facade highlighted by projecting bays connected by a covered open porch.

7.26 Next door Blakesville has more decorative architectural features, the ground floor dominated by a pair of projecting bay windows, linked by a porch canopy supported on substantial carved timber posts. The building wraps around the corner into Back Lane where the pattern of fenestration is less regular and a large carriage opening on the ground floor gives access to a courtyard range at the rear that almost certainly originally contained stables. The windows throughout have been replaced with top hung uPVC casements; although the probable glazing pattern of 8 over 8 sashes remains identifiable, the central stair window (now a fixed unit) was probably a 6 over 9 sash. The impact of the modern windows on the character of the property is most notable when the top hung units are open, particularly on the ground floor bays where the opening lights kick out at a variety of angles. The house has a small enclosed frontage with a cobbled ground surface enclosed by hoop topped modern railings, which fit with the general pattern found within The Square although there is no suggestion that they replace historic railings.

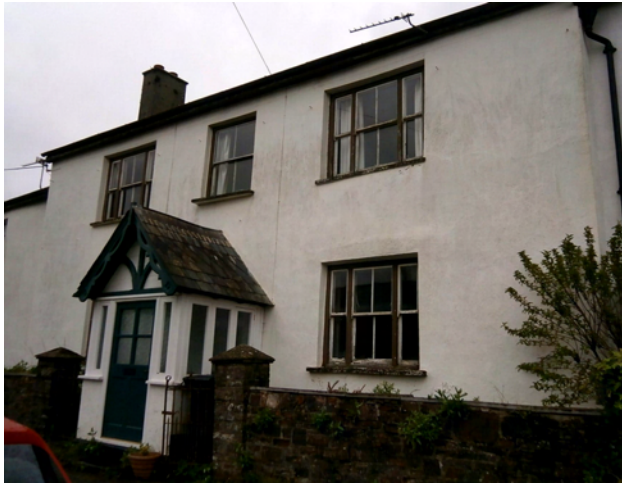
The Old Vicarage is a good example of a Georgian property fronting The Square, with a later porch added.

7.28 The Old Vicarage stands on the north side of The Square just east of Court House. The Old Vicarage, together

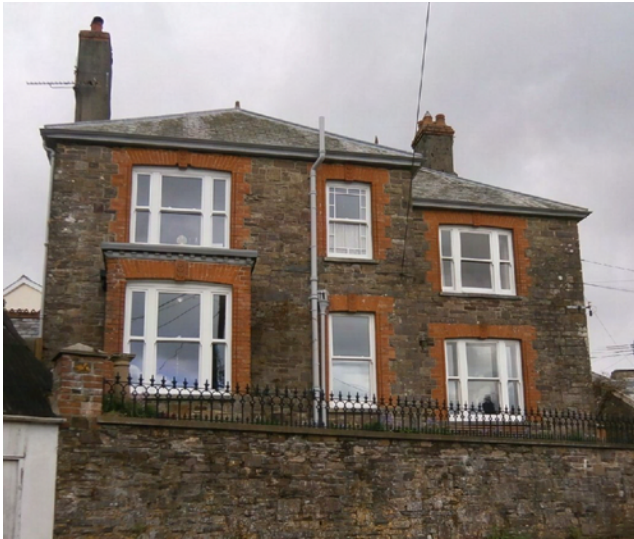
Homedale is an imposing arts and crafts style home standing on high ground to the north side of Fore Street.

square bays on the ground floor also having decorative turned timber spindles and rails on their roofs to provide small balconies accessed via the first floor. The building features a plaque giving the construction date of 1894 and the initials of the Architect "F W W". The elevated grounds of the house are enclosed by a stone retaining wall topped with decorative cast iron railings.

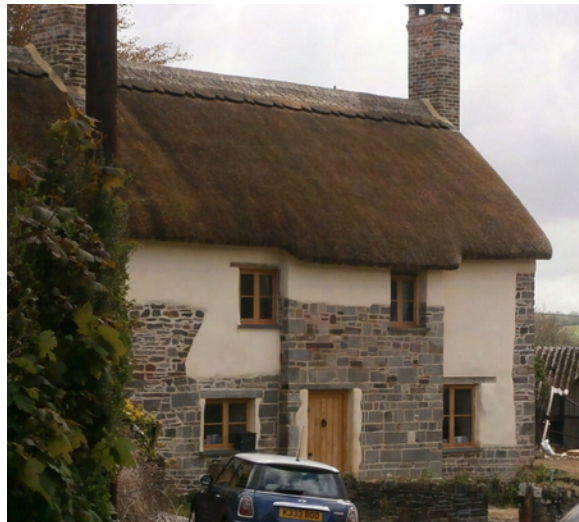
Higher Poole Farm is one of few thatched properties which remain within the village.

8.11 Jury Cottage is the next property along the street and is set back with its gable facing the road. The lane beside this house leads to Higher Poole Farm which sits in behind the main frontage of properties, and is visible in the gap between Jury Cottage and Penswell Cottages. The farmhouse has just been extensively renovated and at present does not show its 17th century origins. The external stonework has been cleaned and re-pointed, the roof re-thatched and fresh render applied to the upper floor. It will be many years before the building weathers in again.

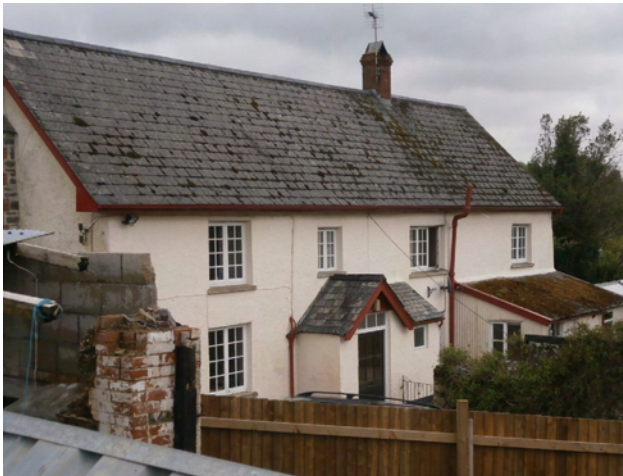
Lower Poole Farm is similar in style to many of the Georgian properties on The Square.

and the beginning of the Georgian period. The building is rendered local stone, with a dressed stone gable end chimney stack. Windows are a mix of 2 (majority) and 3 light

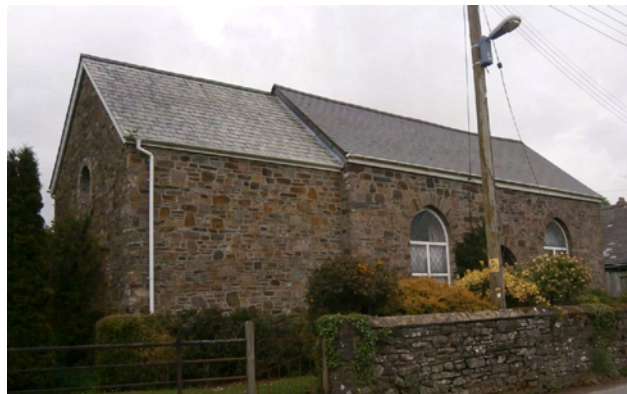
The old Wesleyan Chapel has been converted to residential use, with the Methodists having relocated to East Street in 1891.
